Perfect Stencils Need Hi-Res AOI Inspection

By Holly Wise, Technical Accounts Manager, MicroScreen, South Bend, IN

Why the need for AOI?

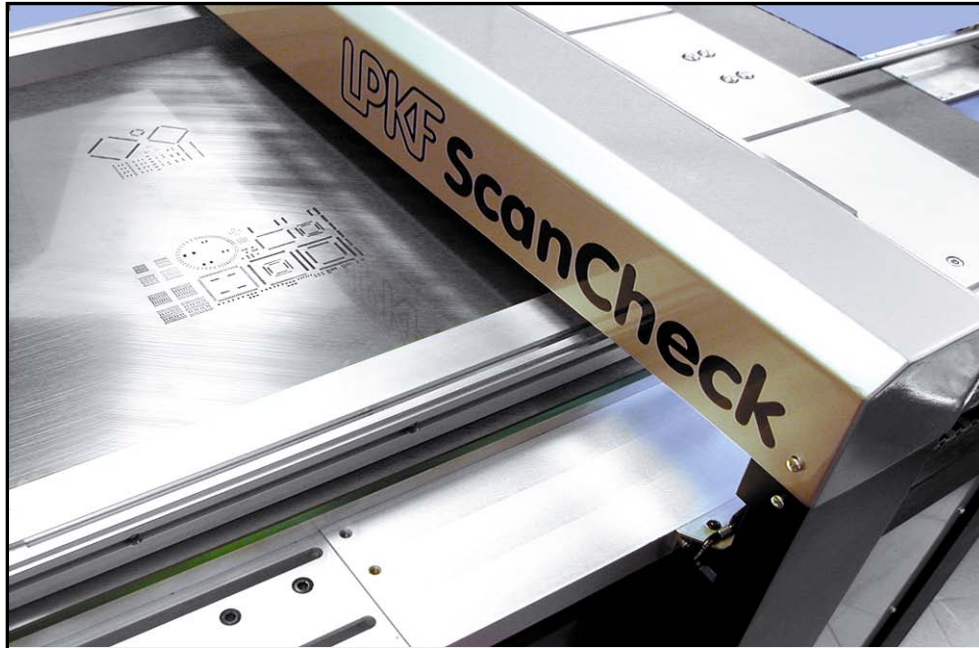
The system is easily operated by placing the stencil on the ScanCheck. High precision guides move the stencil on a granite base over a high-resolution scanner, and the automatic functions of the ScanCheck reduce operator interpretation and allow the scanned data to precisely align to the Gerber data. Alternate AOI systems and scanners used to inspect stencils are slow and have restrictions on the size of the image to be scanned. MicroScreen's AOI scans at 12,000 dpi, while a typical AOI systems scans at 4,000 dpi resolution. Other reasons for selection of this equipment include the ability to scan larger areas – 18.5" x 26" compared to 11.7" x 16.5" characteristic of other equipment.

MicroScreen's LPKF AOI compares the total aperture count from the scanned data to the original Gerber data. The aperture total would also identify extra apertures and pinholes caused by debris in the chemical etching process. Sometimes laser cut apertures are cut through but are not extracted properly and are hung up in the aperture. Similarly, a chemically etched stencil with a deformed aperture caused by resist residue would also be identified.

Another function of the AOI used by MicroScreen is to 100 percent measure every aperture on the stencil. Other AOI systems depend on contrast for aperture definition and require the operator to identify the aperture edge for measurement, which can be an uncertainty much of the time. Incorrectly sized apertures can be caused by the laser beam being out of focus or the laser equipment being on the wrong settings. Underetching or overetching will make the apertures too small or too large throughout the pattern.

In addition to the aperture count, positional accuracy is inspected. If any of the scanned apertures are misaligned with the Gerber data due to an out-of-focus laser beam or non-calibrated laser equipment, the operator is alerted with a % error and the misaligned apertures are highlighted.
